Analysis of Three UH-60 Blackhawk Servolink Components P/N 70400-08110-061

ARL-TR-2646

Marc Pepi, Victor Champagne, Daniel Snoha,
Scott Grendahl, and James Catalano
Weapons and Materials Research Directorate, ARL

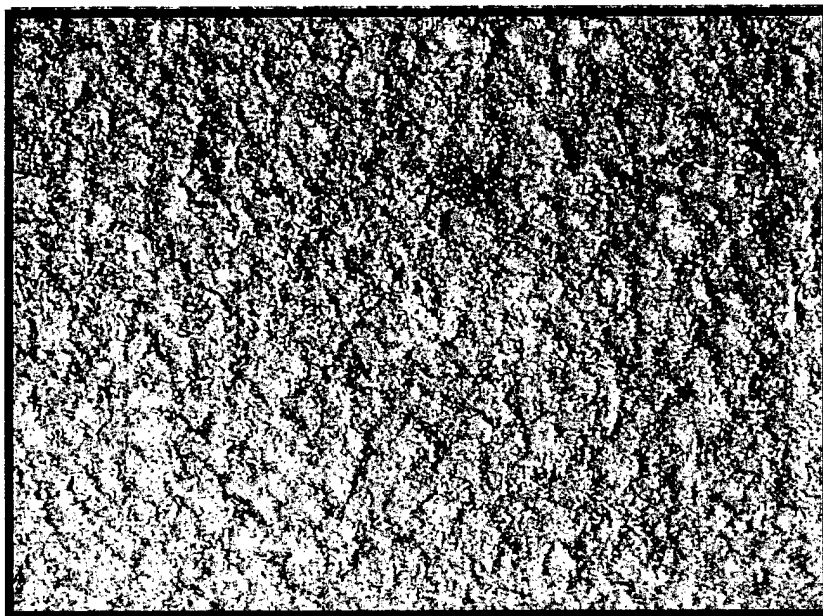
To the unaided eye, the parts appeared to have a non-uniform shot-peened surface; in other words, some regions appeared to have a more pronounced dimpled topography than other regions. In general, the 1.125-in diameter exhibited the most pronounced dimples, while the region adjacent to the bearing raceway contained less pronounced dimples. However, as Figures 2 and 3 show, each of the areas was indeed shot peened, and they contained dimples. Figures 4 and 5 show these representative areas at higher magnification. Each servolink showed evidence of peening on the entire outer surface.

Figure 2. Macrograph representative of the "well-pronounced shot-peening dimples." Magnification 11.75x.

Figure 4. Magnified view of Figure 2 ("well-pronounced shot-peening dimples"). Magnification 56 \times .

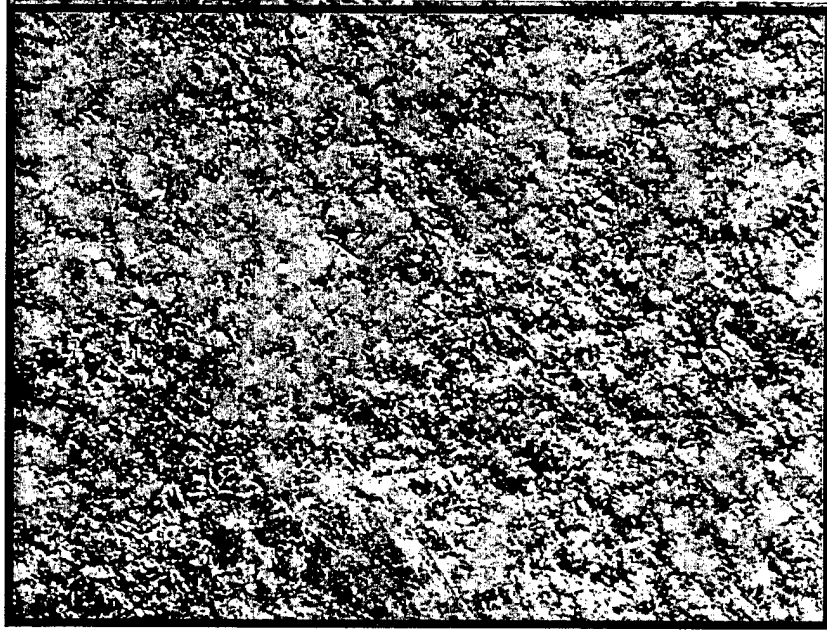
Figure 3. Macrograph representative of the "fine dimples." Also note regions appear less dimpled. Magnification 11.75 \times .

Figure 5. Magnified view of Figure 3 ("fine dimples"). Note the regions that appear less dimpled. Magnification 56 \times .

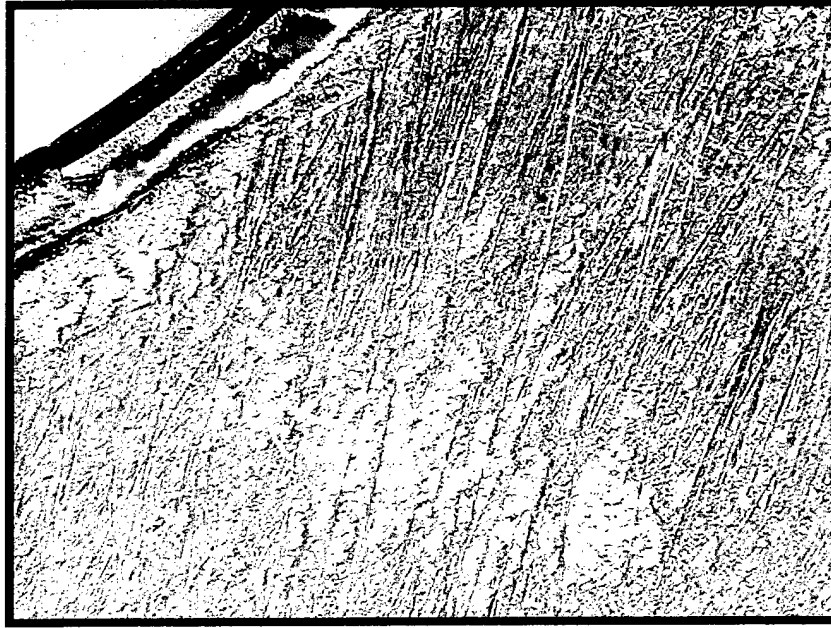
bearing where this was not the case. Figures 11 and 12 show this area at low magnification. At higher magnification (Figures 13 and 14), the scratches did not appear to be deformed by the peening operation. In fact, the scratches seemed to smear the peened dimples such as to eliminate evidence of prior peening. Upon closer examination, however, peened dimples could be observed distributed sporadically among the scratches. Aside from these localized areas, ARL did not find evidence of any other scratches induced after the peening process.

Figure 11. Scratches adjacent to the bearing on servolink 01266. Magnification 11.75 \times .

Figure 12. Scratches adjacent to the bearing on servolink 01268. Magnification 11.75 \times .

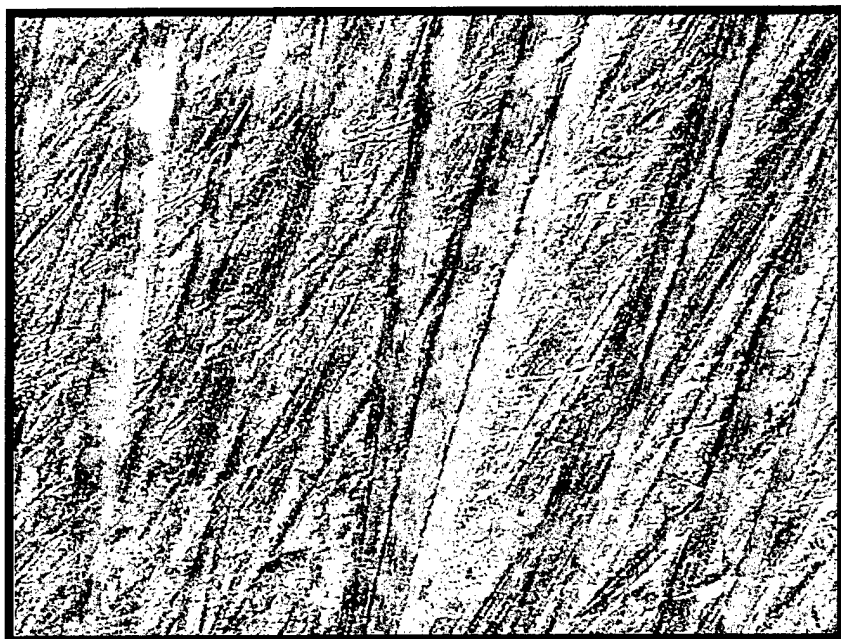
Figure 13. Scratches adjacent to the bearing on servolink 01266 at higher magnification. These scratches did not appear to have been shot peened. Magnification 56 \times .
